Purpose: CERCLA Site Inspection

Site: Buckeye Properties
1296 Armstrong Ave.
San Francisco, CA

Date of Inspection: February 3, 1993

Report Prepared By: James M. James

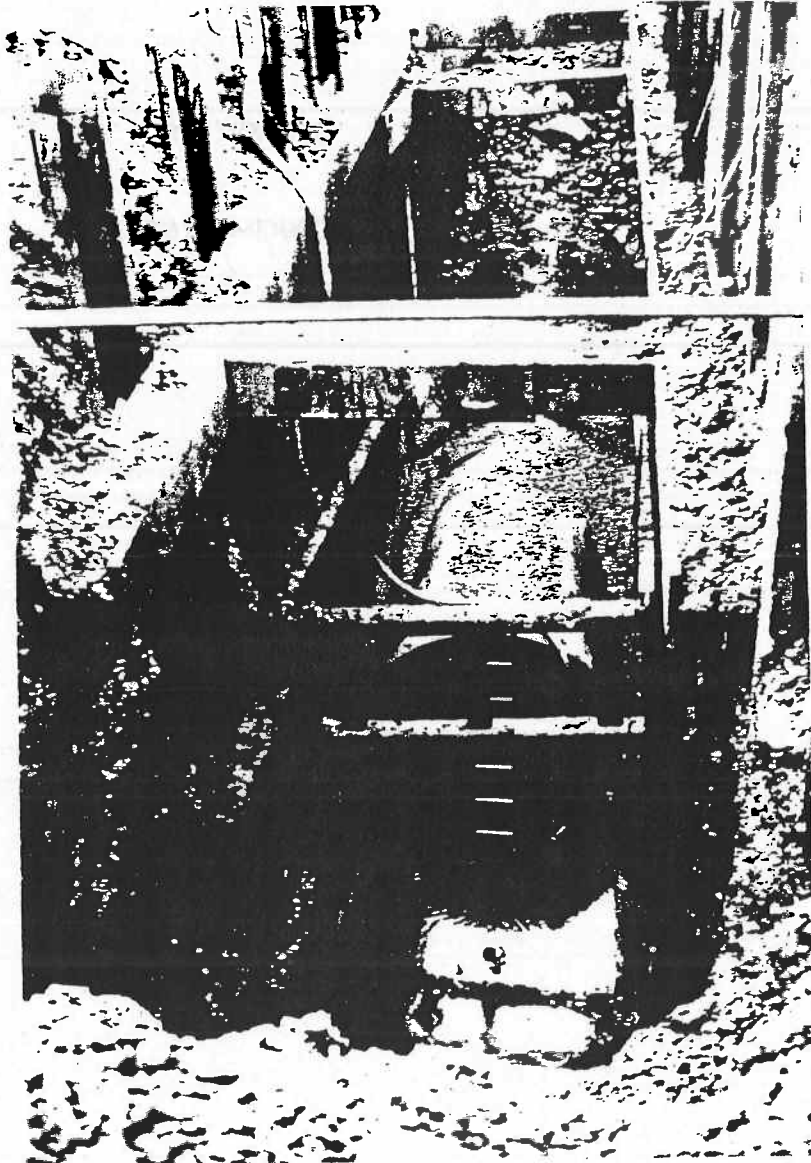
DESCRIPTION- According to Mr. Ricci: This photograph shows the excavation for the 1986-1987 City of San Francisco sewer consolidation project; The excavation was 10 to 40 feet deep and the pipe was 8 feet in diameter; and the liquid around the pipe is waste material that smelled like creosote.

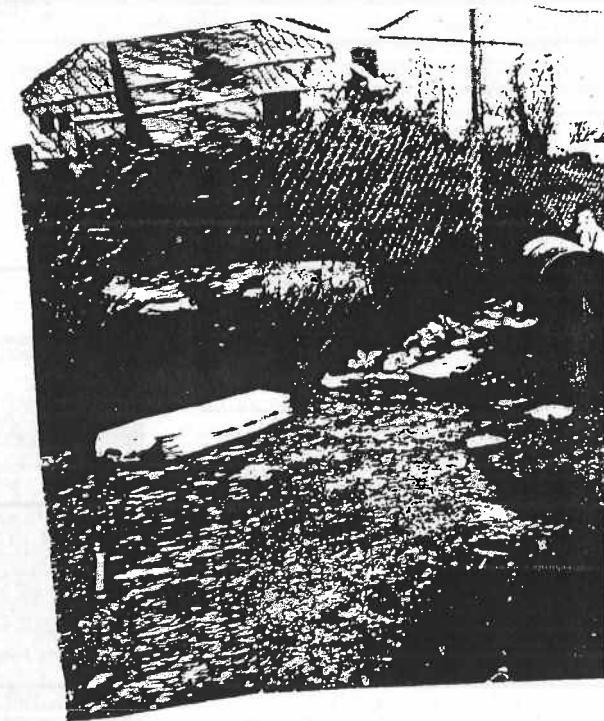
View northeast along old Navy railroad track, and miscellaneous debris. This area is not on Bu
